REPORT NO: MT-13/037-E

GUARDRAIL TESTING OF CORONET KWICK-STAGE MODULAR SCAFFOLDS

CLIENT: CORONET SCAFFOLD GROUP SUZHOU CO., LTD
SIFC SIP, SUZHOU CITY
JIANGSU PROVINCE, CHINA
P: +86-512-85557000 F: +86-512-85557111

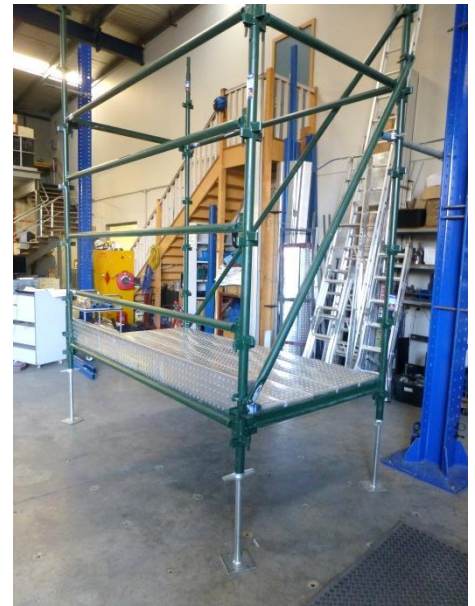
FIG.1
TEST ASSEMBLY

A test scaffold was assembled to provide a single 2.4m long bay, 1.2m wide & single lift high test assembly (see Fig.1). A working platform was assembled at the first lift using 2.4m steel battens supplied by the client. An additional steel batten was erected as a toeboard in accordance with the client's installation instructions using the supplied toe board brackets.

Ledgers were installed at 0.5m (nom.) intervals to act as a scaffold guardrailing system in accordance with the following definitions as provided in AS/NZS 1576.1:

- Guardrail: 'The highest rail (ledger) in guardrailing fixed parallel to the platform'
- Midrail: 'Rails (ledgers) fitted equidistant between guardrailing and the platform'

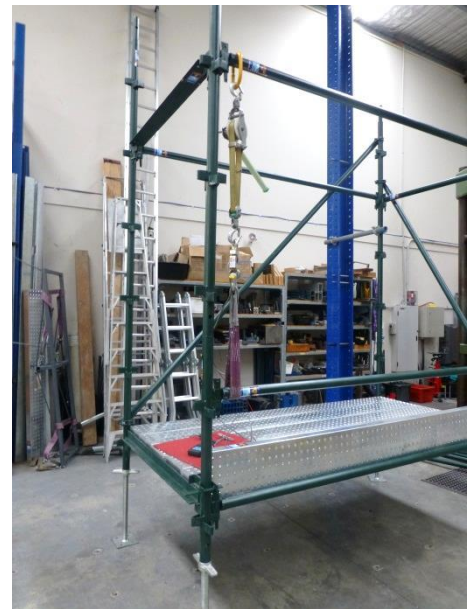
FIG.2
LOAD TEST OF V-LOCATING LUG CONNECTION

A concentrated upward load of 300N \approx 30.6kg was progressively applied to the guardrail adjacent to the V-locating lug connection point (see Fig.2). The test load was maintained for a period of 15 minutes.

After a period of 15 minutes, no signs of failure or dislodgement of the connection was visually evident. Upon removal of the test load no sign of residual deformation or slip between the connected components was evident.

Load testing of the V-locating lug was conducted in accordance with AS/NZS 1576.1-CLAUSE 2.5.3.2 (C) to test the adequacy of the connection between scaffolding components. Prior to testing, the V-locating wedge was knocked into the V-pressing using a hammer in accordance with the client’s installation instructions.

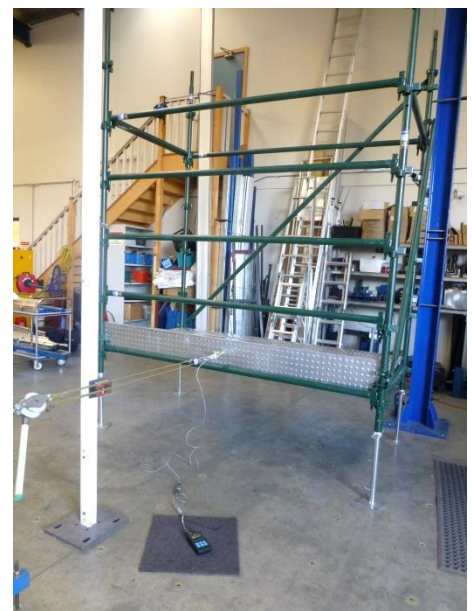
FIG.3
LOAD TEST OF TOEBOARDS

A concentrated load of 150N \approx 15.3kg was progressively applied to the centre of the batten at the midspan position (see Fig.3). Calibrated MTS laser displacement devices were utilized to capture the outward displacement at the midspan of the toeboard and the adjoining standards. The test load was maintained for a period of 15 minutes. The net deflection of the toe board relative to the adjoining standard is provided as follows:

- Net rail deflection recorded $\delta = 15\text{mm} < \delta_{\text{max}} 45\text{mm}$ **PASS**

Upon removal of the test force, the toeboard and adjoining standards were observed to elastically rebound to the original position.

Load testing of toeboards was conducted in accordance with AS/NZS 1576.1-CLAUSE 2.5.3.2 (E) in conjunction with the serviceability criteria specified by CLAUSE 2.7.4 (E). In accordance with the client’s installation instructions, a 2.4m steel batten was installed on the scaffold test assembly to provide a toeboard and or kick plate on a working platform. The toe board was held vertically captive using toeboard brackets supplied by the client. The toe board brackets were clamped to the standards at each end of the scaffold test assembly.

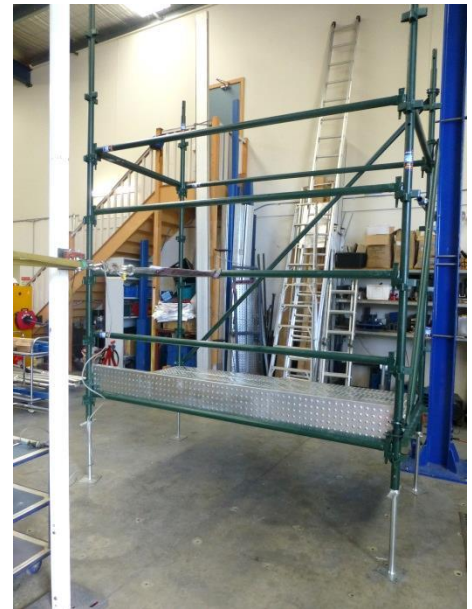
FIG.3
LOAD TEST OF MIDRAIL

Static Midrail Test Data

Mid-span of Midrail outward to $175\text{N.m}^{-1} \approx 420\text{N}$

Midrail Deflection: 13mm

Post Deflection: $4\text{mm} < \delta_{\text{max}} 35\text{mm}$ **PASS**

Midrail-to-Post Deflection: $\delta = 9\text{mm} < \delta_{\text{max}} 35\text{mm}$ **PASS**

Residual Guardrail-to-Post Deflection $\delta = 1\text{mm}$

Load testing of guardrails, midrails and guardrail posts was conducted in accordance with AS/NZS 1576.1-CLAUSE 2.5.3.2 (C), (D) and (F) respectively. The serviceability criteria of the guardrails, midrails and guardrail posts was governed by AS/NZS 1576.1-CLAUSE 2.7.4 (A) and (D) respectively. Load testing of guardrails and midrails was conducted by applying concentrated loads at the midspan of the test items (see Fig.4). Calibrated MTS laser displacement devices were utilized to capture the outward displacement at the midspan of the guardrail and midrail; as well as the adjoining standards. The test load was maintained for a period of 15 minutes.
